Manhole Inspection Summary

Manhole # S31K__028MH

Location Address: **630 Emory St**

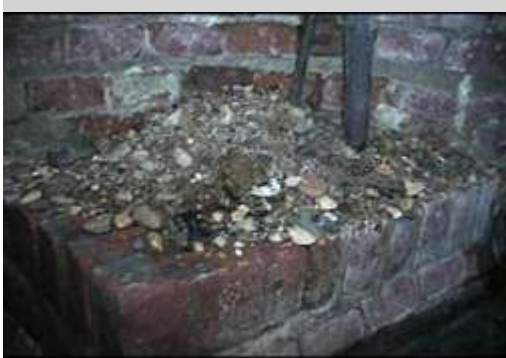
Miscellaneous

bench debris

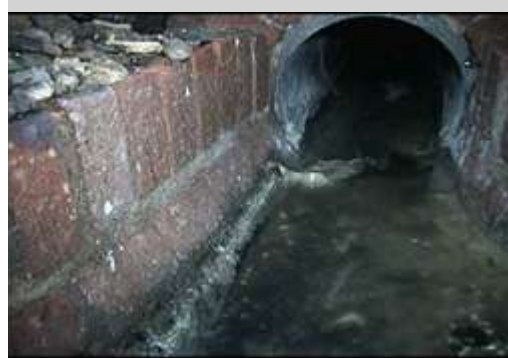
Miscellaneous

channel debris

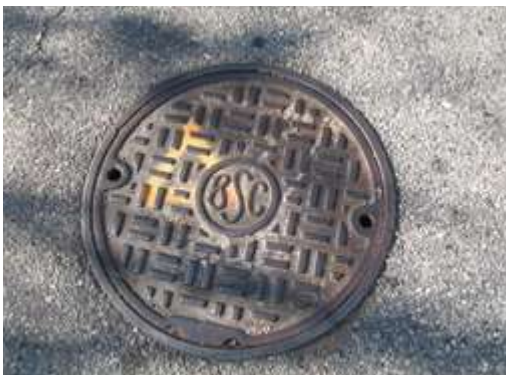
Miscellaneous

MH cover

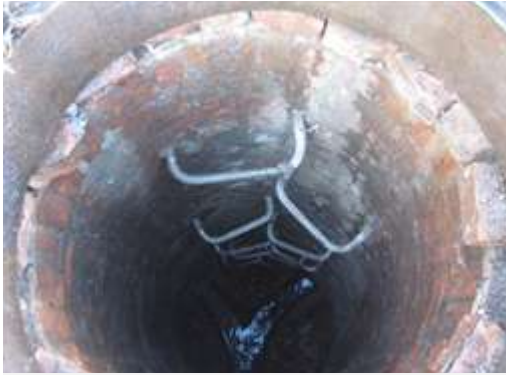
Defect 6

☒ **Wall**

chimney & corbel infiltration at wall

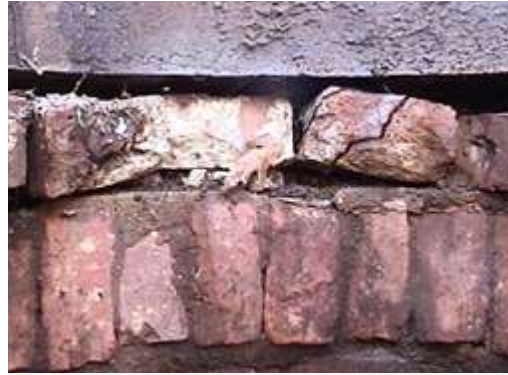
Defect 2

☒ **Cracked**

☒ **Loose Brick**

☒ **Joint**

chimney cracked and loose bricks,
chimney infiltration at frame joint

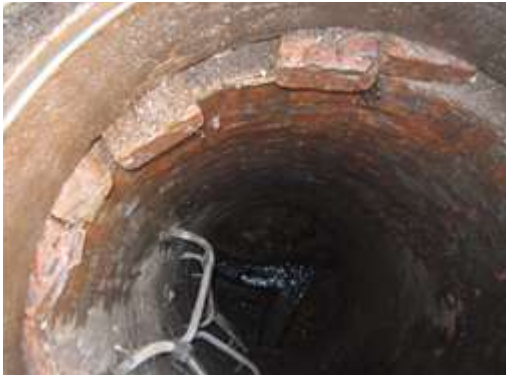
Defect 1

Offset: **1.5** (in.)

☒ **Leaks**

frame offset 1.5 inch, frame infiltration at
cover

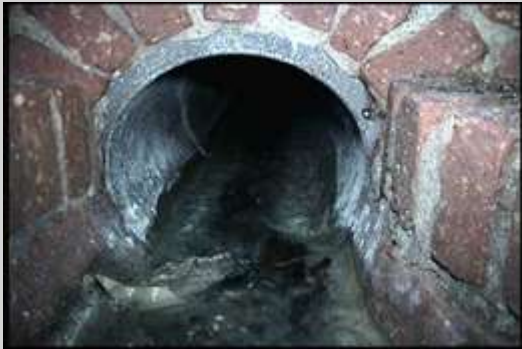
12 O'Clock Outflow

Pipe Height: **10.8** (in.) Rod and Bar (Angled)
Pipe Material: **Clay** ☐ Pipe Lined
Invert Depth: **15.48** (ft.) Flow Characteristics: **Fast**
Deposits: ☒ None ☐ Mud ☐ Sludge ☐ Debris ☐ Grease
Silt Depth: **0** (in.) Deposits Extent:
Infiltration: **None** Pipe Seal Cond: **Sound**

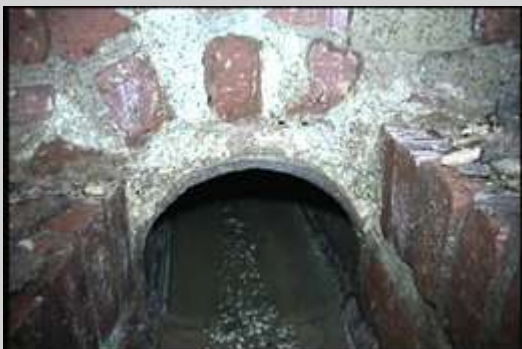
4 O'Clock Inflow

Pipe Height: **8.4** (in.) Rod and Bar (Angled)
Pipe Material: **Clay** ☐ Pipe Lined
Invert Depth: **15.42** (ft.) Flow Characteristics: **Fast**
Deposits: ☒ None ☐ Mud ☐ Sludge ☐ Debris ☐ Grease
Silt Depth: **0** (in.) Deposits Extent:
Infiltration: **None** Pipe Seal Cond: **Sound**
